Manhole Inspection Summary

Manhole # **S19C__023MH**

Insp Date: **10/12/07 2:36 PM**

Location Address: **500 BRICE-PAYSON**

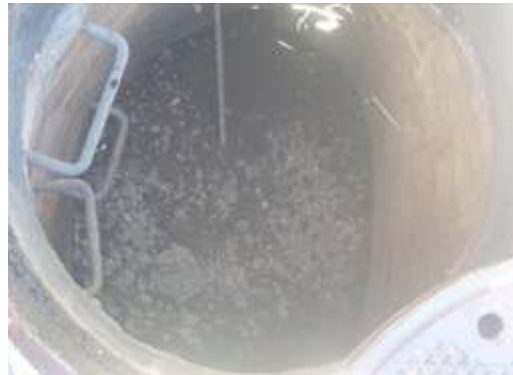
Top View

DEBRIS IN CHANNEL

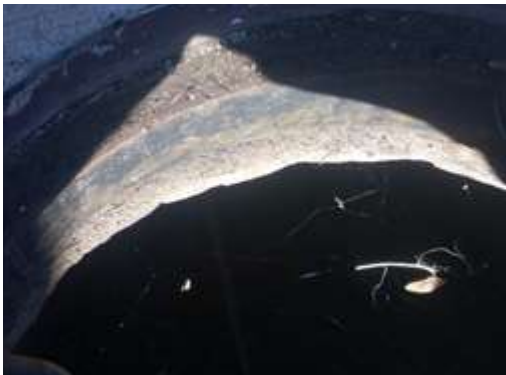
Defect 1

Frame Offset: **1** (in.) Condition: ☒ Sound ☐ Cracked ☐ Leaks

FRAME OFFSET

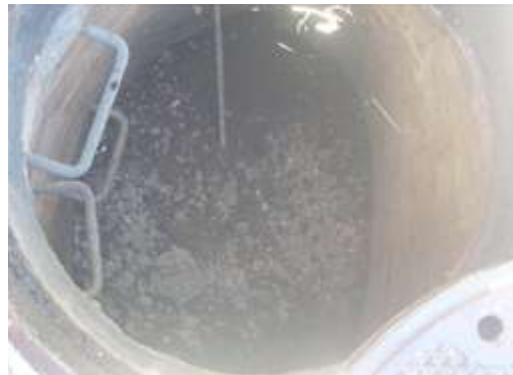
Defect 2

DEBRIS IN CHANNEL

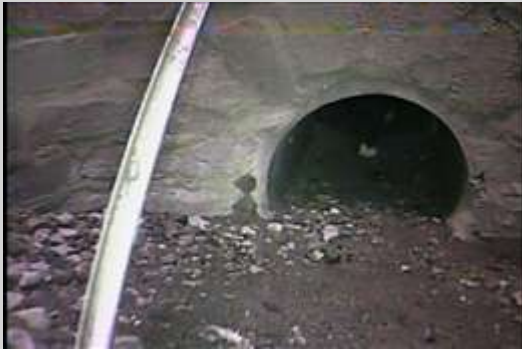
12 O'Clock Outflow

Deposits: ☐ None ☒ **Mud** ☐ Sludge ☐ Debris ☐ Grease

Silt Depth: **2** (in.) Deposits Extent: **Light**
